June 16, 2015

MEMORANDUM

SUBJECT: Impromptu visual cap inspection at the San Jacinto River
Waste Pits superfund site

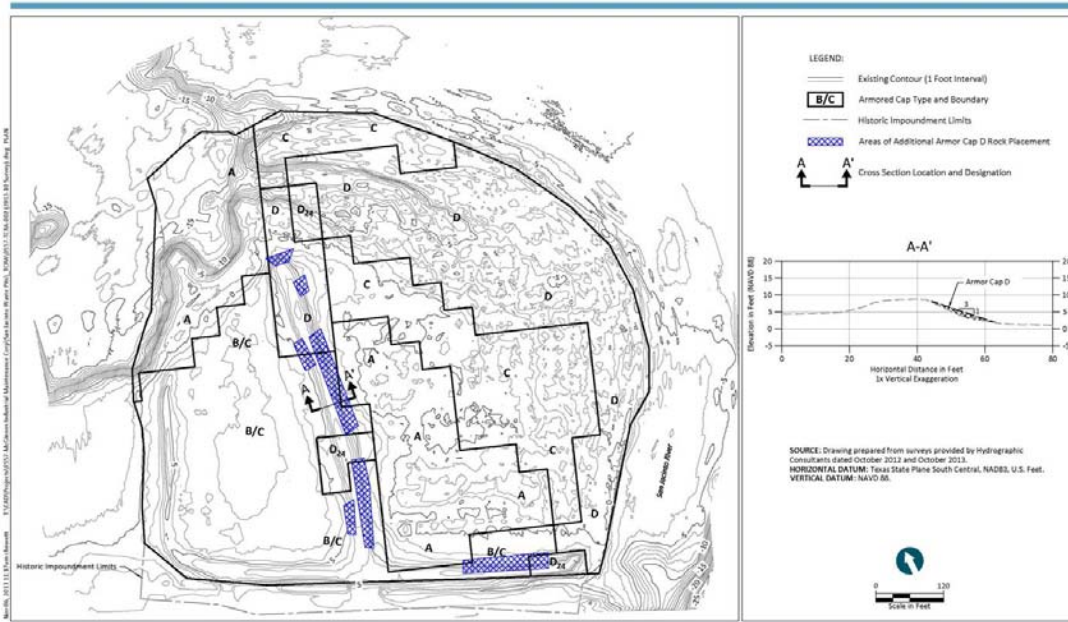
In addition to inspecting the overall integrity of the armor cap, seven additional areas (see Figure 1) were inspected where additional rock was placed and the slopes flattened to provide more stability and strength per the enhancement work plan dated November 2013. The section of the armor cap located above water level (western cell) was observed to be intact with no areas of cap erosion evident (see Photo 1-2). It was noted that several small areas of minor cap erosion along the central berm were evident by patches of the geotextile filter fabric exposed (See Photos 3-5).

Figure 1
Armor Cap Repair Plan
San Jacinto River Waste Pits Superfund Site

Figure 1- Areas covered with additional rock and flatten slopes from November 2013
Armor Cap Enhancement plan

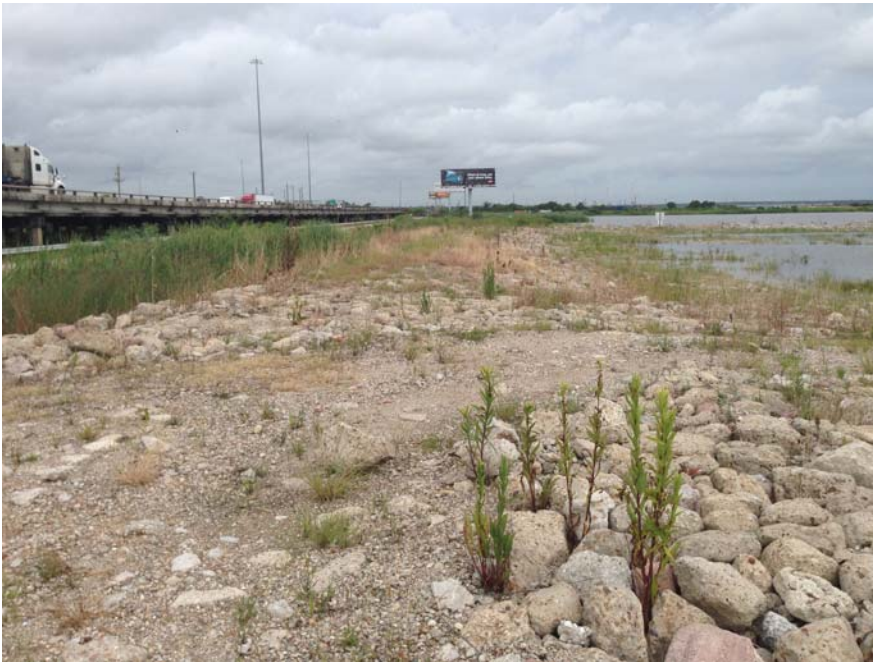
Photo 1- View of southern berm (looking west) and Western Cell surrounded by vegetative growth along San Jacinto River

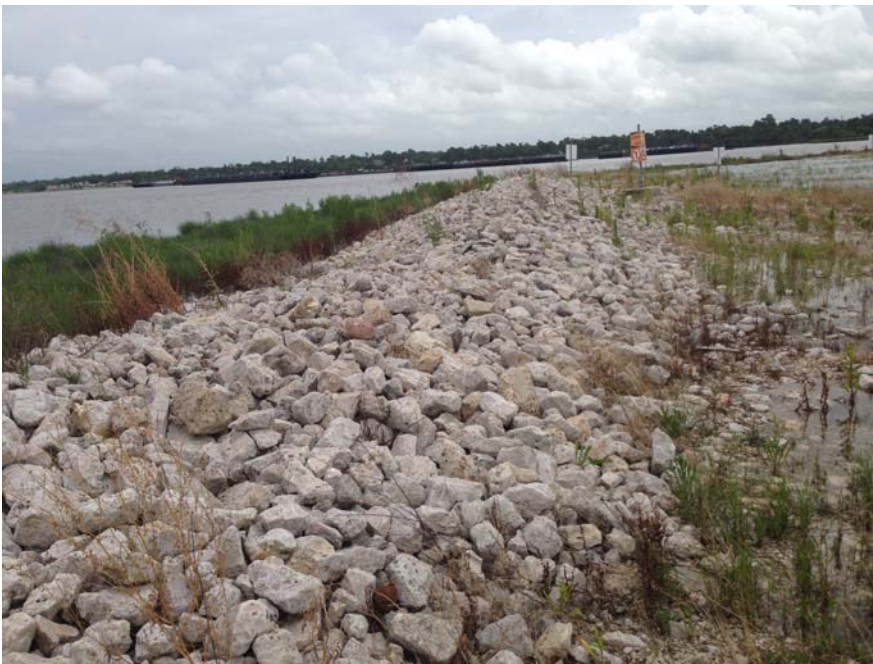
Photo 2- View of western berm along western cell (looking north towards San Jacinto River).

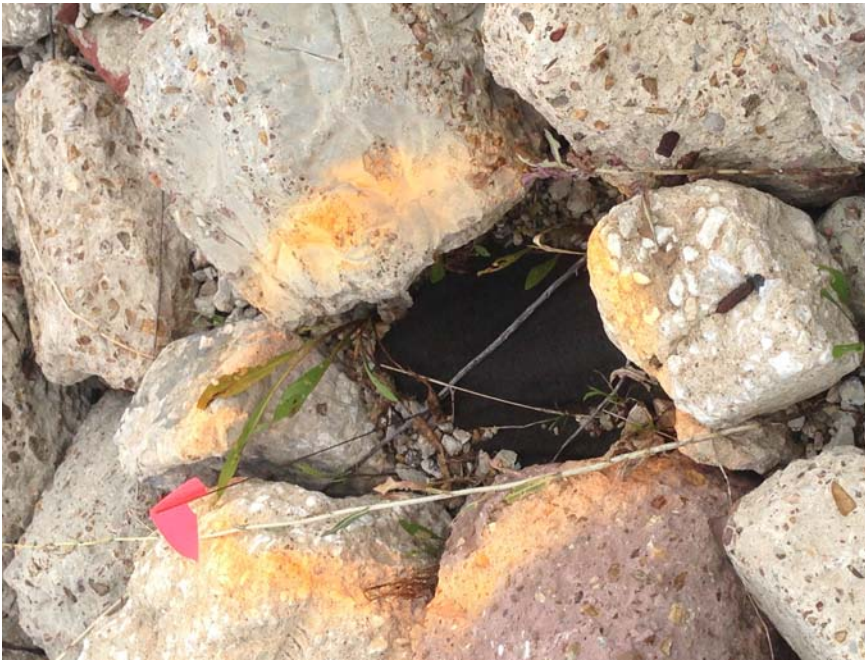
Photo 3- Magnified view of one area along central berm with geotextile fabric exposed

A review of the respondents TCRA monthly monitoring report dated June 15, 2015, have indicated no major problematic areas needing cap repair or maintenance. However, due to this most recent visual cap inspection conducted on June 15, 2015, several areas of the armor cap are needing immediate attention for minor deficiencies. The first item needing immediate attention is the placement of additional armor material along the small areas identified in this report, second, an additional application of weed control and maintenance is needed in areas with new vegetative growth, and lastly, a site walkthrough and removal of any vegetative growth that might obstruct site signage along the entire perimeter is needed.

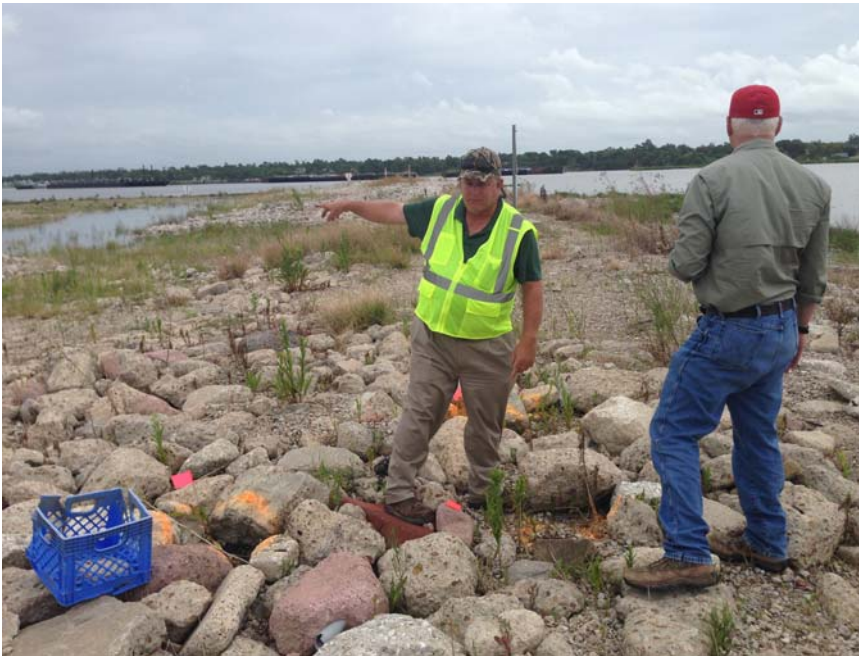
Photo 4- Areas along central berm (identified with orange paint) where geotextile fabric is exposed

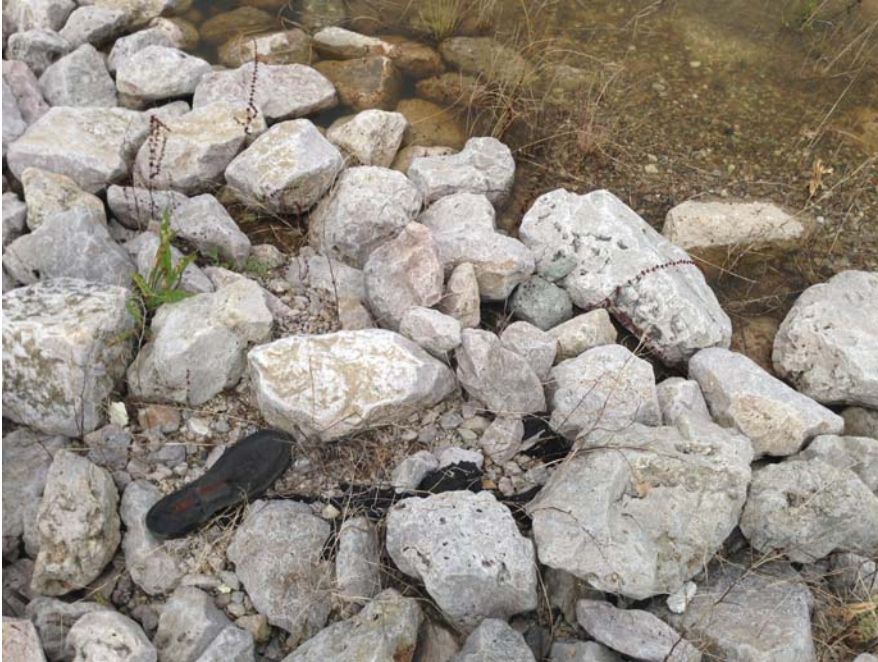
Photo 5- View of small area (note scale with size 10 shoe) where geotextile fabric is exposed located along the northern part of central berm and east along eastern berm.

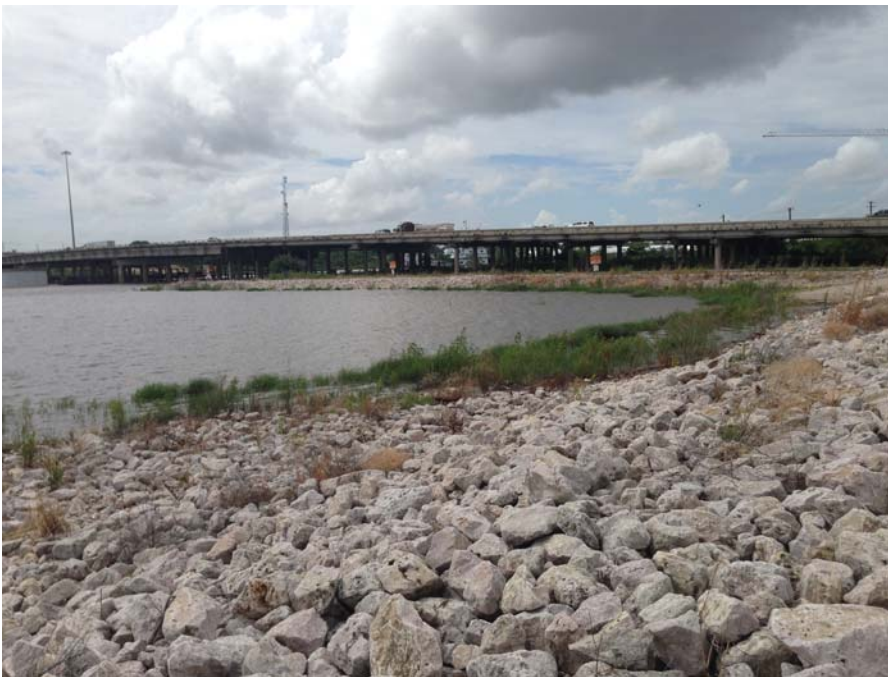
Photo 6- View of eastern cell looking south east towards I10

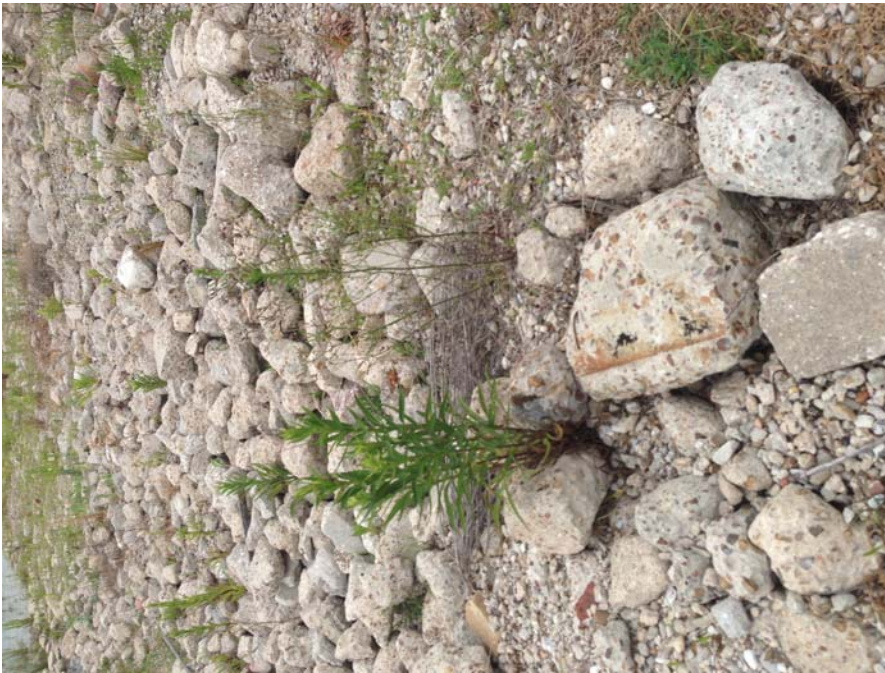
Due to the recent rains and flooding in the area, it was noted that a higher abundance of vegetative growth needing maintenance and control is needed (See Photo 7). It was noted during the cap inspection that prior vegetative maintenance and control was evident due to the brown and dead weeds, however more aggressive treatment and additional applications are warranted due to the increasing appearance of new vegetative growth.

Photo 7- View of vegetative growth along eastern berm.

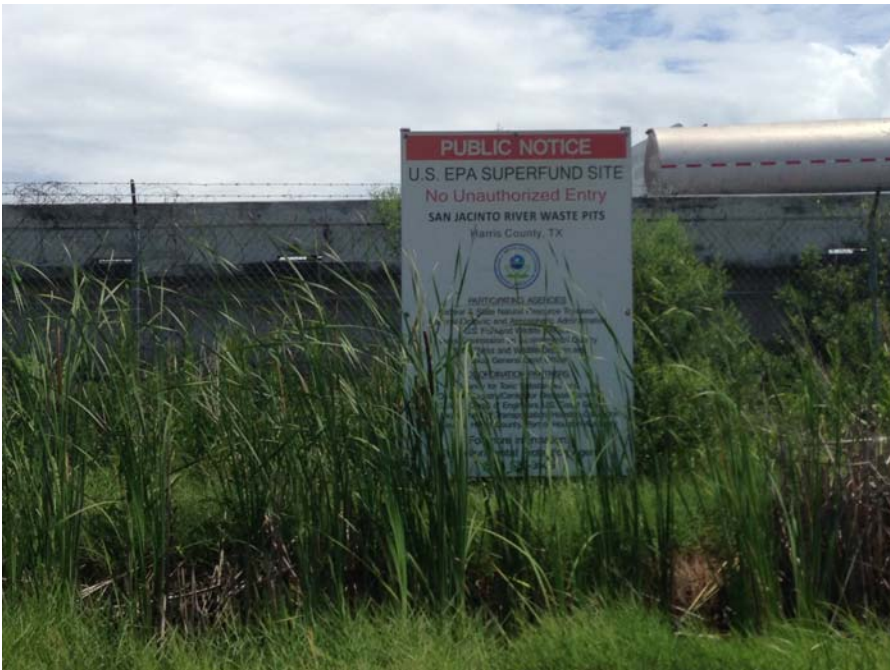
On June 15, 2015, EPA RPM Leos conducted a site visit to document observations at the San Jacinto River Waste Pits superfund site. During the site visit it was noted that the Site security fencing visible and intact. Site signage placed along the fencing perimeter was visible and intact with the exception of the southern gate located south of I10 which has an overgrowth of weeds and shrubs obstructing part of the signage (See Photo 8).

Photo 8- View of vegetative growth obstructing site signage near southern gate south of I10.
